The Laboratório de Análise de Materiais por Feixes Iônicos-LAMFI of the Institute of Physics of the University of São Paulo has been installed an external beam facility for PIXE analysis. This new setup is being used for the analysis of archeological pottery artifacts, paintings and biological tissues (teeth and bones), which are not compatible with the high vacuum of the regular PIXE target chamber. Applications of this facility will be presented in the analysis of a Brazilian painting of the beginning of the last century.

The Accelerator LAMFI

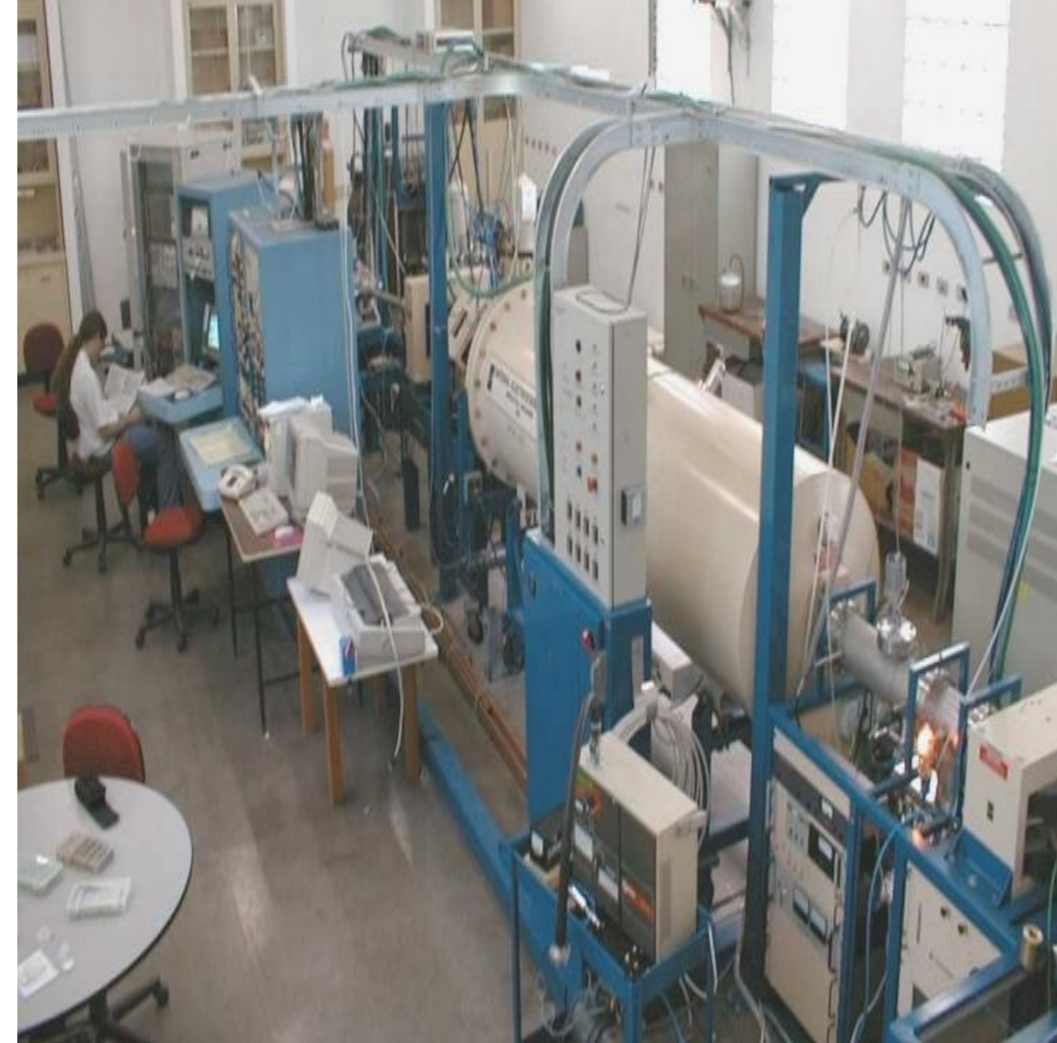
General View of the LAMFI with the Pelletron tandem Accelerator, $V_{max} = 1.7$ MV

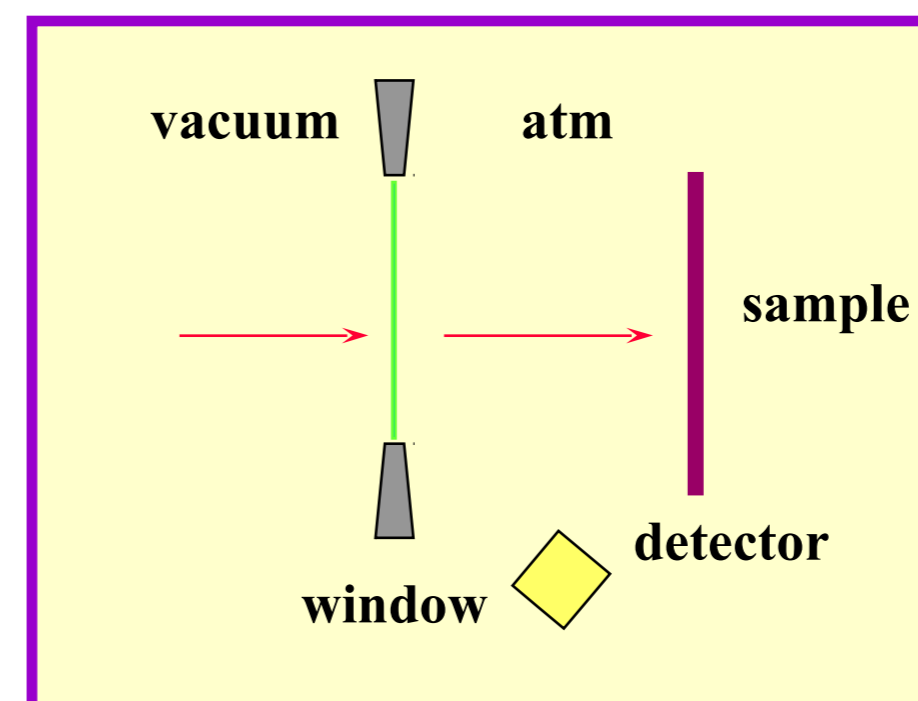
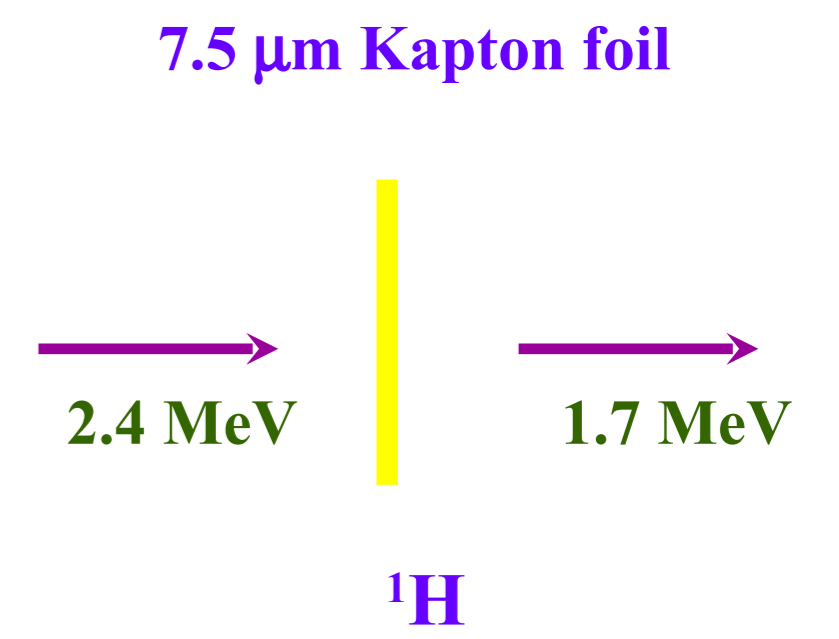
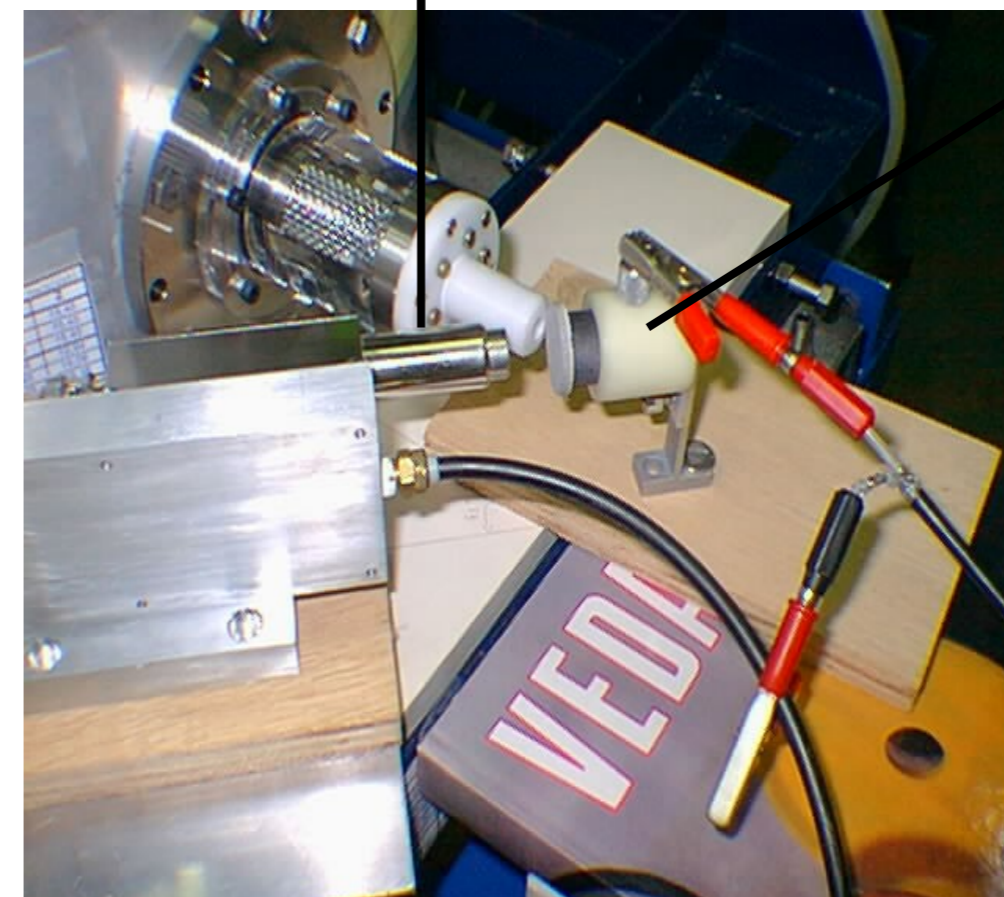
This new experimental setup optimizes the beam path through a carbon collimating ring placed inside a transparent perspex tube. To prevent electrical breakdowns the internal wall of the perspex tube was covered with a metal net, which avoids interference of electrical noise in the X-ray spectra.

Some views of the external beam setup

In the measurements a 2.4 MeV proton beam, after passing through a 7.5 μm thick Kapton exit foil and 10 mm air path, reached samples with a final energy of 2.2 MeV. For X-ray detection a portable AMPTEC XR-100CR (Si-PIN) mounted on a water-cooled (FWHM 220eV@MnK α) kindly provided by Dra. Carmem C. Bueno, from IPEN-SP was used. This detector was placed about 10-15 mm from the target at an angle of 135 degrees related to the incident beam. To avoid the entrance beam into the detector a mylar absorber of 12 μm was placed in front of the detector.

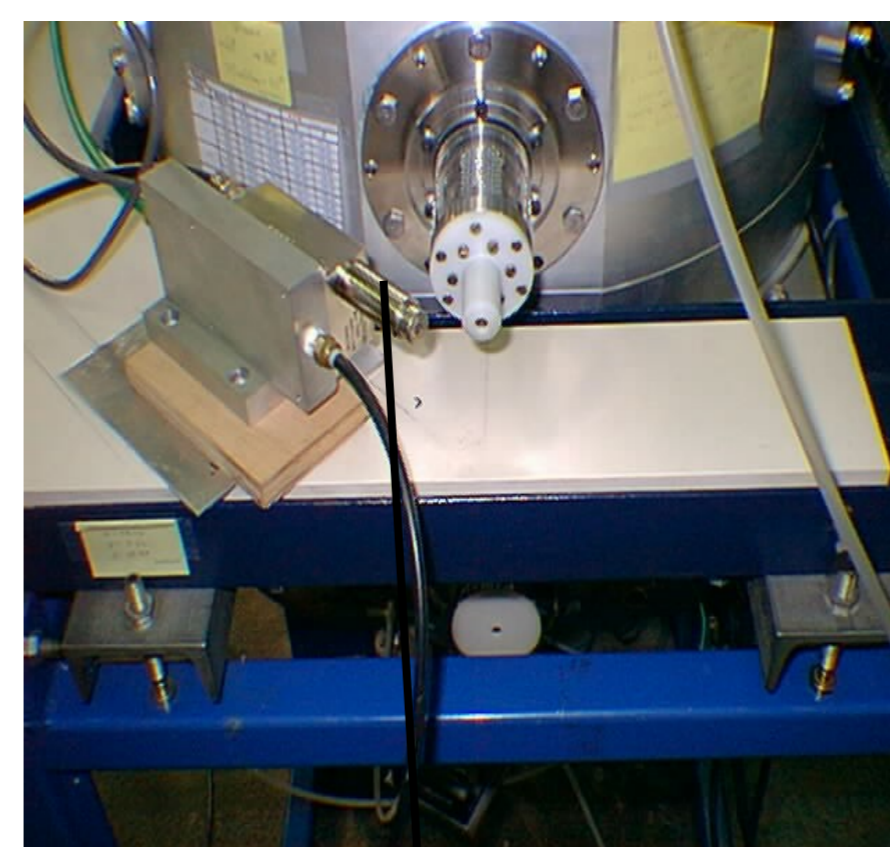
X-Ray detector (XR-100CR).

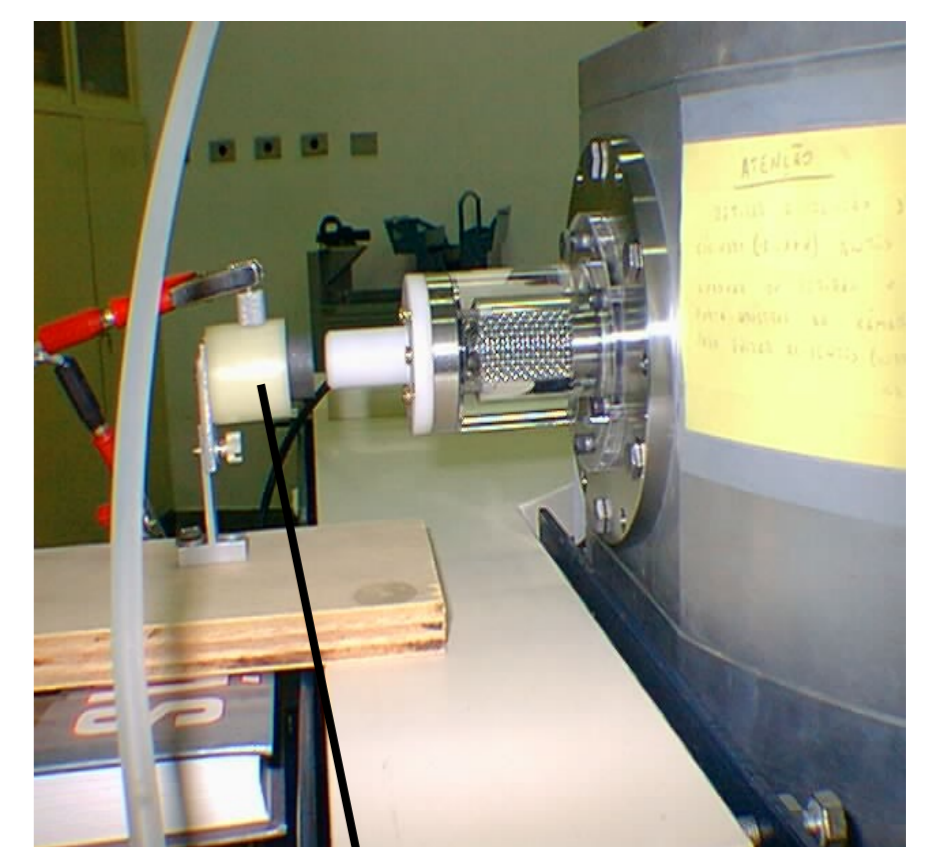
Carbon Faraday cup

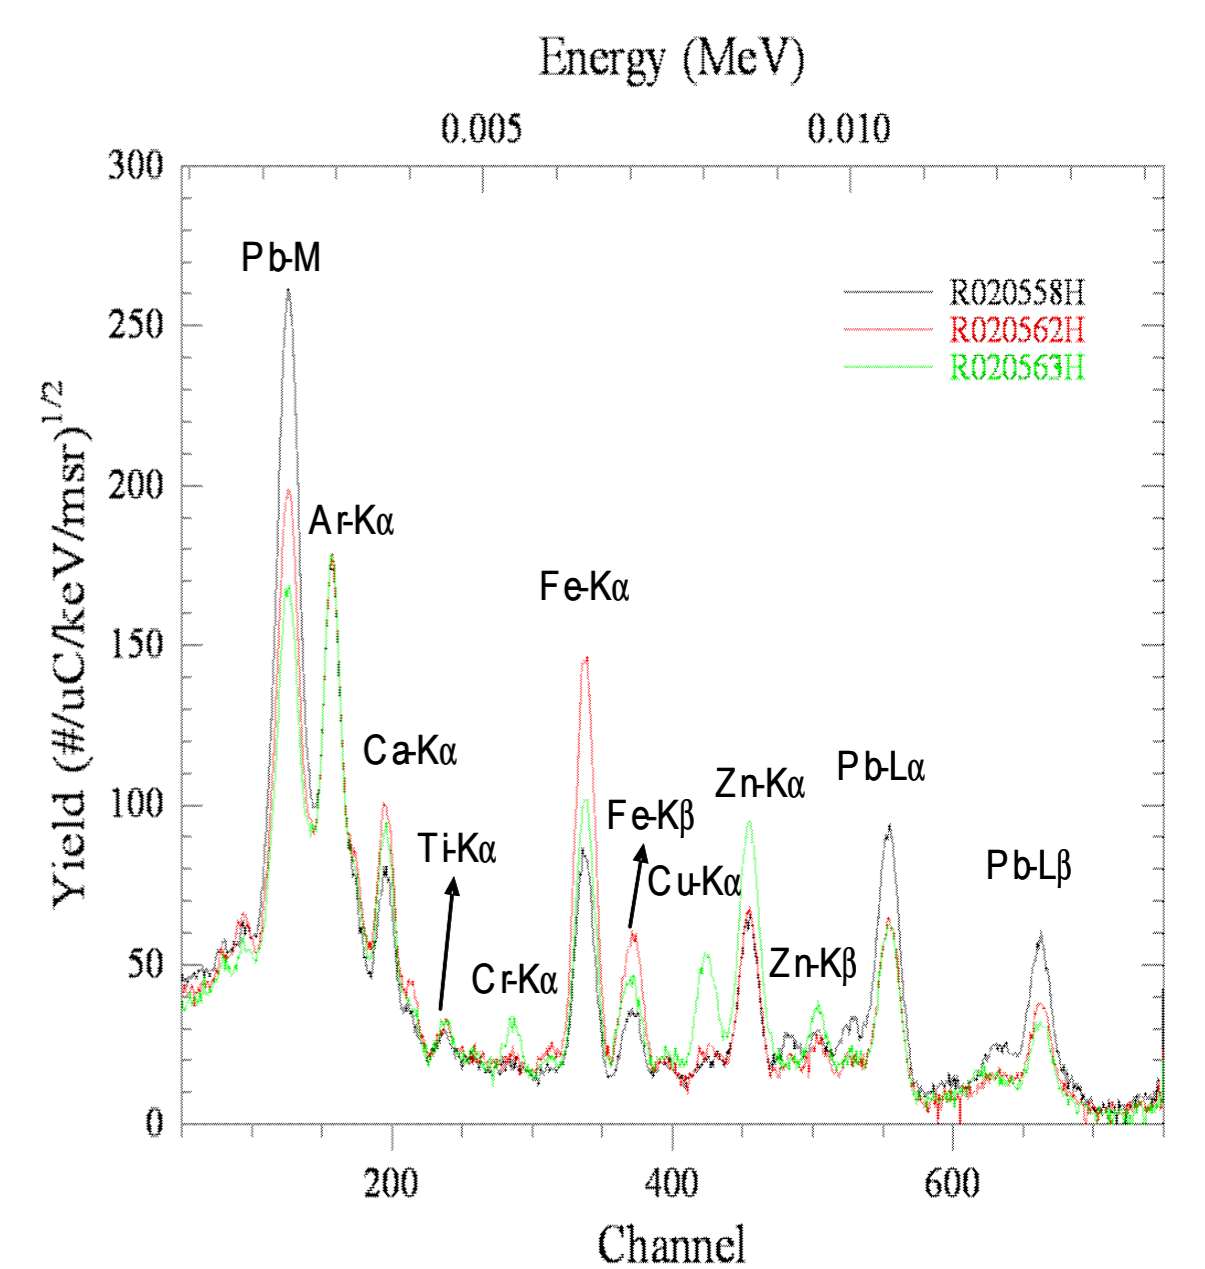
The PIXE spectra from brown group is shown corresponds to select point 3(dark brown) curve in black, 5(light brown) in green and 7(intermediated brown) in red. The greater difference is the presence of chromium and copper in the light brown. However there are intensities differences in lead, iron and zinc. The high intensity of Pb in point 3 (light brown) is in relation to the mixture of white color.

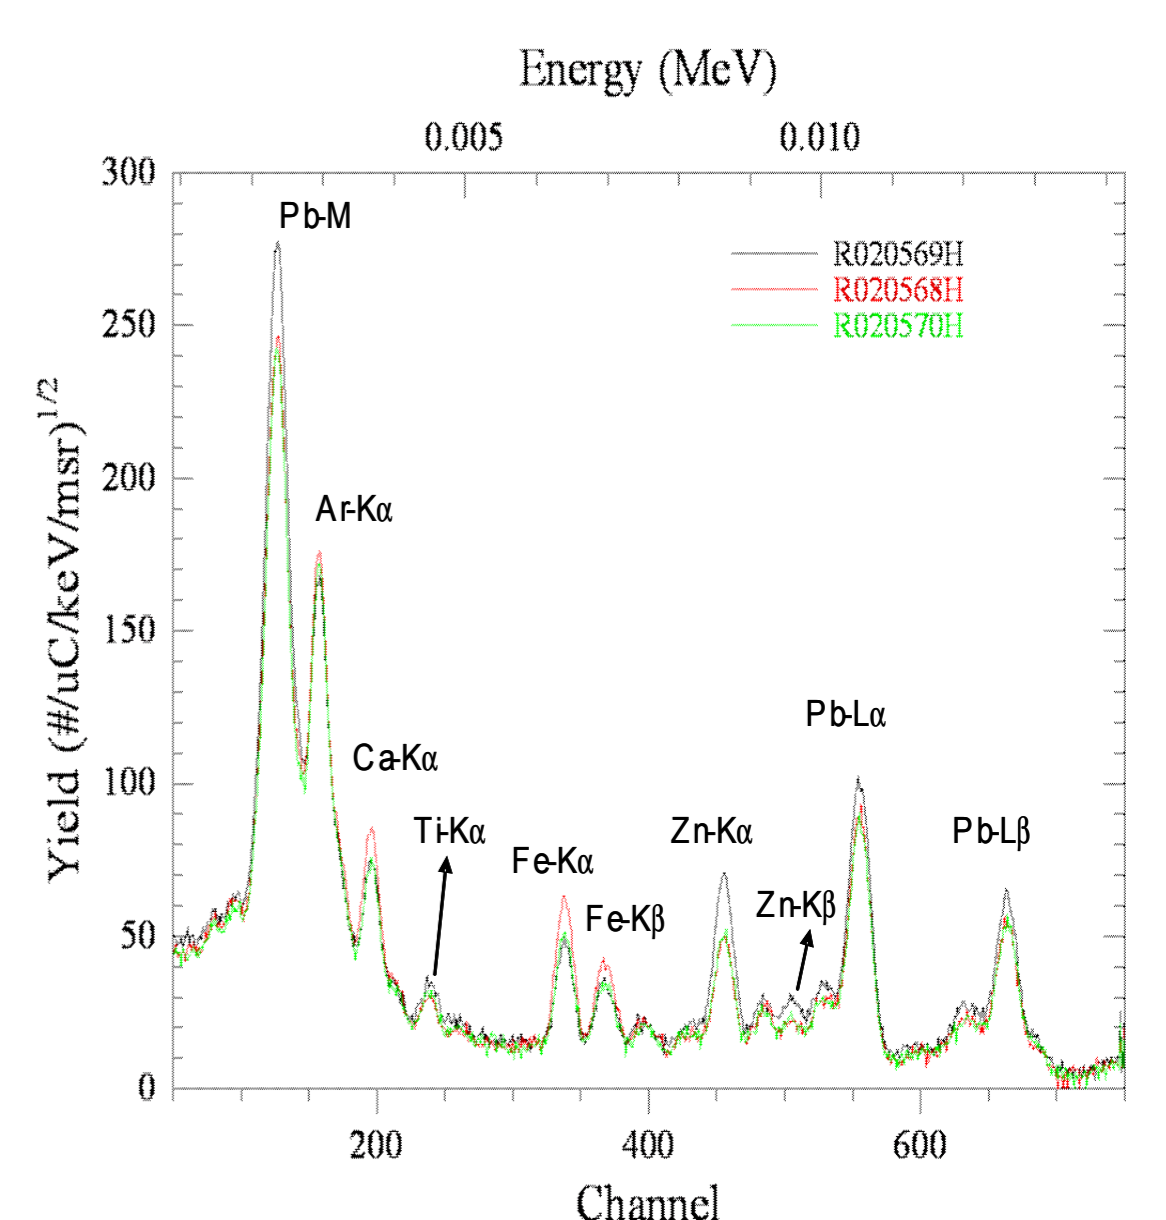
All points of the blue group (10 curve in green, 11 in red and 12 in black) in spectra PIXE show similar intensities for Ti. At point 11 – dark blue the intensities of Zn and Pb are little more than in points 10 – mountain blue and 12 – light blue. The intensities of calcium and iron at point 12 are slightly greater than in other points.

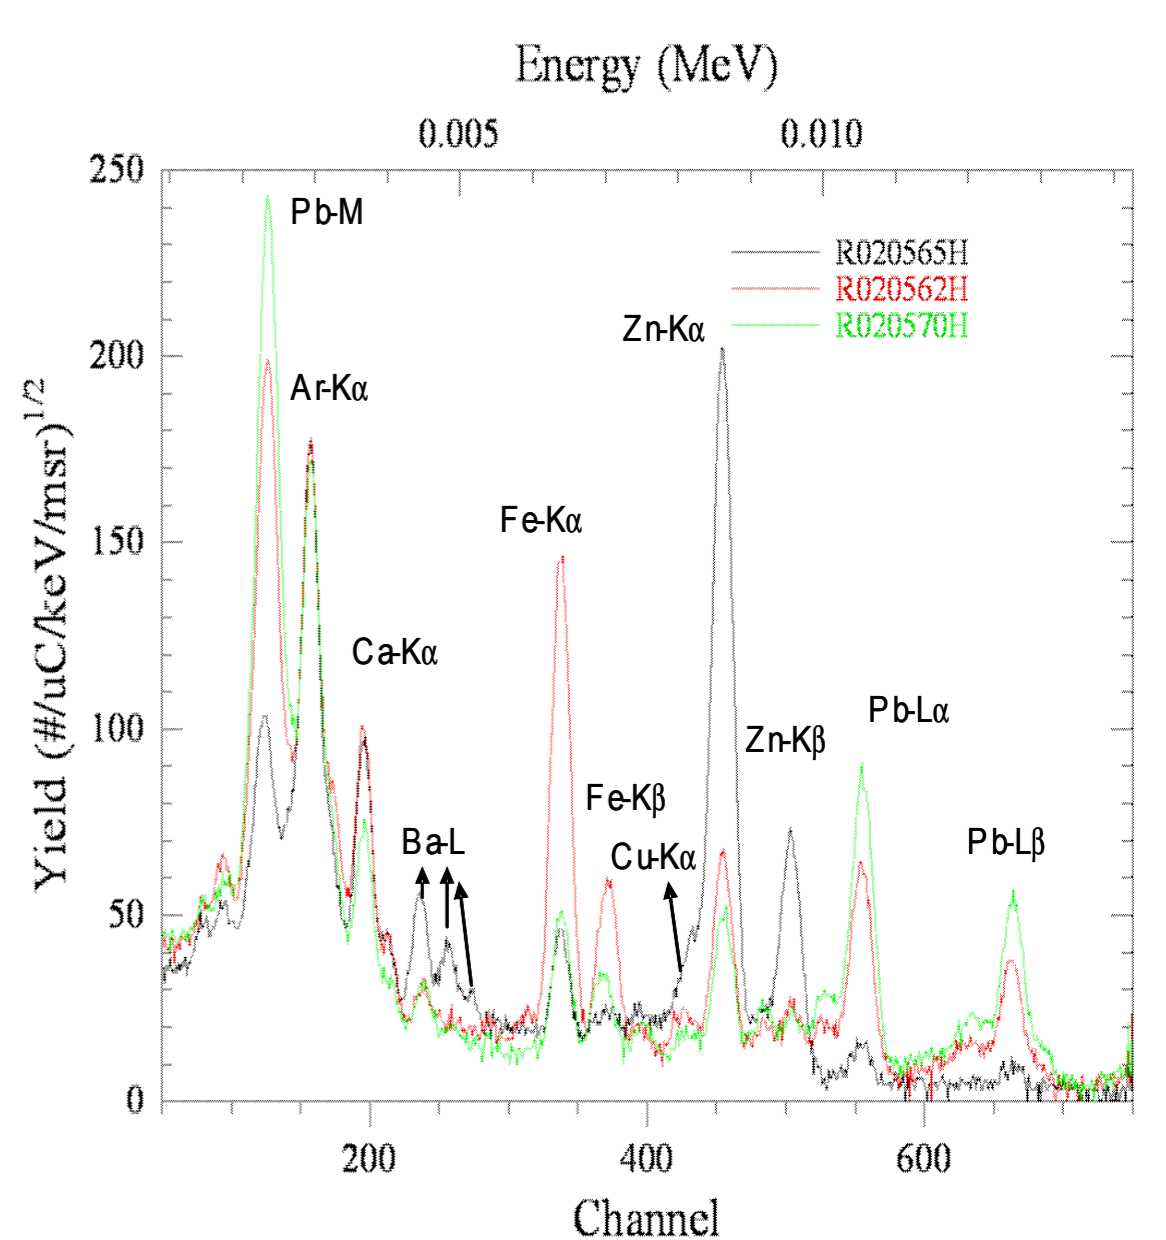
PIXE spectra show from points 2 – damaged white (curve in black), 7 – intermediate brown (in red) and 10 – mountain blue (in green). The greatest intensities differences appear in the damaged white point. At it there are almost no Pb and more zinc and copper than at the other points. PIXE spectrum from damaged white is the only showing barium K-lines, probably from priming. The point of intermediate brown presents more iron than that of mountain blue and damaged white.
